# RENOVATION OF A MASTER BATH

the story of the never-ending renovation

2008—2010

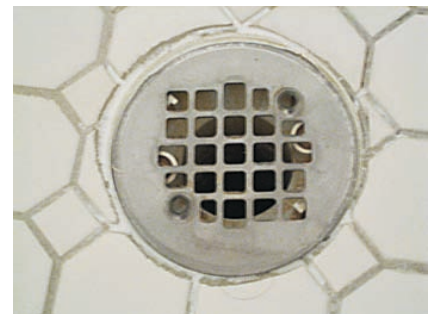
#### INITIAL REPAIR 2

The tile was cut very haphazard. Here is a photo of the drain with extra-thick grout-lines being filed with caulk after the grout had come out.

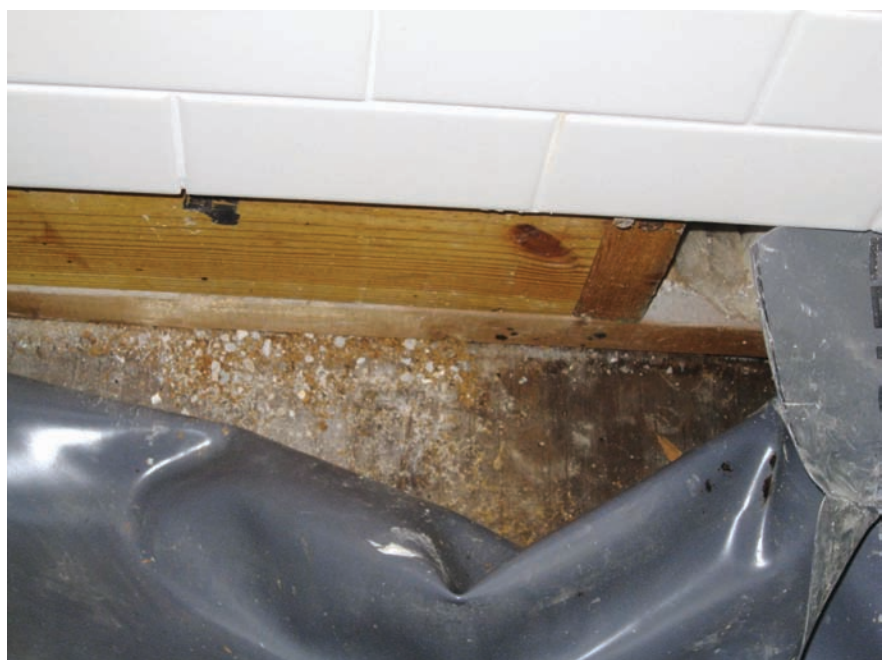
Figure A

As you can see by the diagram (FIG A), a mortar bed was supposed to be installed prior to the OATEY shower pan liner.

1. For typical wood subfloor cut a 4.5" diameter hole in the center of the shower floor where the tile shower drain would normally be positioned. Disassemble the *tile shower drain*. Lay the tile shower drain base in the opening so the flange of the drain base rests on top of the subfloor. Solvent weld the drain base to the drain pipe using the appropriate solvent cement. See Figure A.
2. Cover the drain base opening with duct tape to keep debris from entering the drain. Begin by applying Portland Sand/ Cement mixture mortar bed over the subfloor at 1/4" per foot slope from the wall framing to the top of, but not over, the drain base. After this step the sloped mortar bed should be flush with the top surface of the drain base.

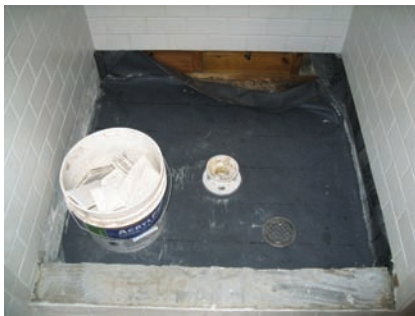
**AFTER THE TILE WAS REMOVED**  
Shows the shower pan liner with tile removed.

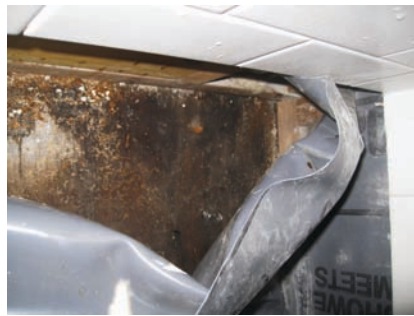
**DETAIL 1**  
Another view showing the wet plywood directly beneath the shower pan liner. (Should be a mortar bed.)

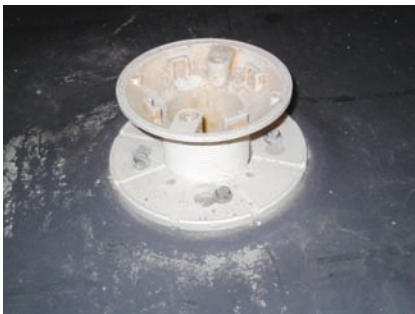
**SLOPED UP TO DRAIN**  
Shows the shower pan liner actually sloping upwards towards the drain. Water has to climb uphill to get out.

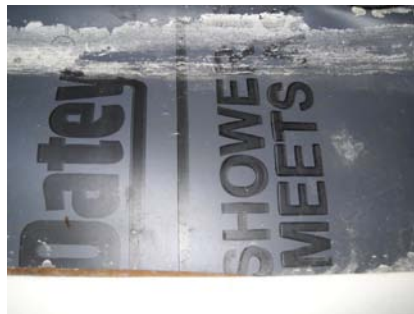
**OATEY SHOWER PAN LINER**  
'A Bath Pro' would not install the shower pan liner according to the manufacturer's installation instructions.

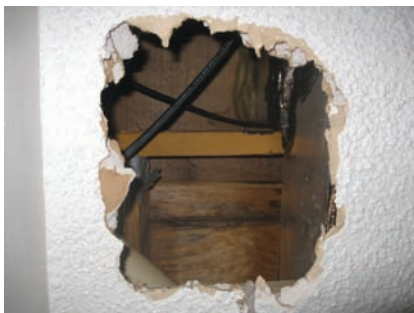
**CEILING (DETAIL1)**  
Shows the damp plywood where the water came through.

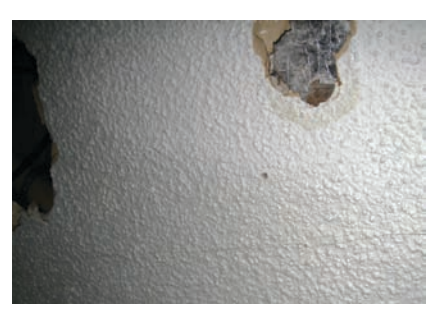
**CEILING (DETAIL2)**  
The hairline crack where water damaged the ceiling a second time.
